MUTLUSAN PLASTİK ELEKTRİK SAN. VE TİC. A.Ş TEST REPORT

Testing of two models of luminaires IP65 to classify the degree of protection provided

202100890TUR-001

Proje No: /Project Number	IST21Q.1028.00
Tarih: /Date	23.12.2021
Hizmet: /Service	IP 65
Ürün: /Product	Model LEDLIGHT-2 (016 038 70X200, 016 038 70X211) Model LEDLIGHT-4 (016 038 70X400, 016 038 70X411)
Ürün Tanımı: /Product Description	Luminaire
Firma İsmi: /Company Name	Mutlusan Plastik Elektrik San. Ve Tic. A.Ş.
Firma Adresi: /Company Address	İkitelli O.S.B. mahallesi Enkoop caddesi No:7 Başakşehir/Istanbul/Turkey
Kontak Kişi & Pozisyonu: /Contact & Position	Nihat BALCI

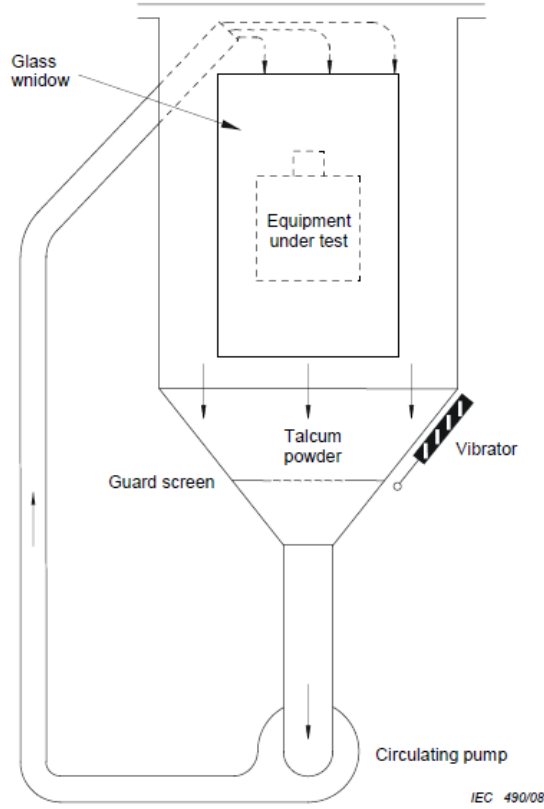
Figure 6 – Apparatus for proving protection against dust

9.2.1 Dust-proof luminaires (first characteristic IP numeral 5) shall be tested in a dust chamber similar to that shown in Figure 6, in which talcum powder is maintained in suspension by an air current. The chamber shall contain 2 kg of powder for every cubic metre of its volume. The talcum powder used shall be able to pass through a square-meshed sieve whose nominal wire diameter is 50µm and whose nominal free distance between wires is 75µm. It shall not have been used for more than 20 tests.

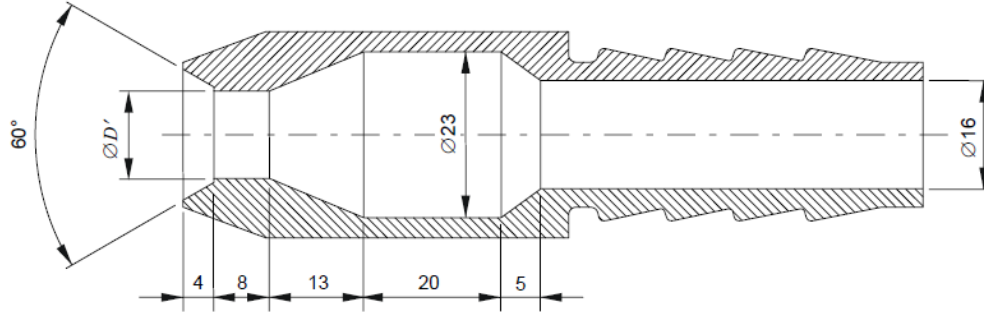
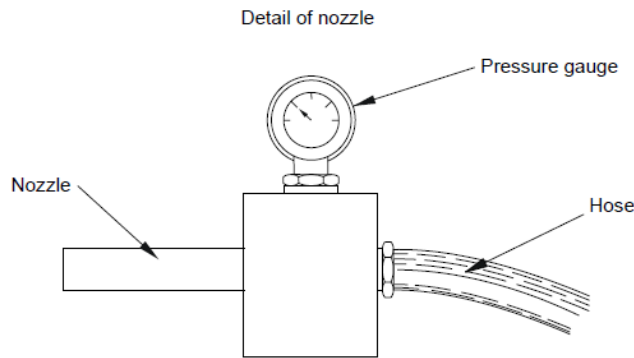
$D' = 6,3$ mm for the test of 9.2.6 (second characteristic numeral 5)
 $D' = 12,5$ mm for the test of 9.2.7 (second characteristic numeral 6)

Figure 8 – Nozzle for spray test

9.2.6 Jet-proof luminaires (second characteristic IP numeral 5) are switched off and immediately subjected to a water jet for 15 min from all directions by means of a hose having a nozzle with the shape and dimensions shown in Figure 8. The nozzle shall be held 3 m away from the sample.

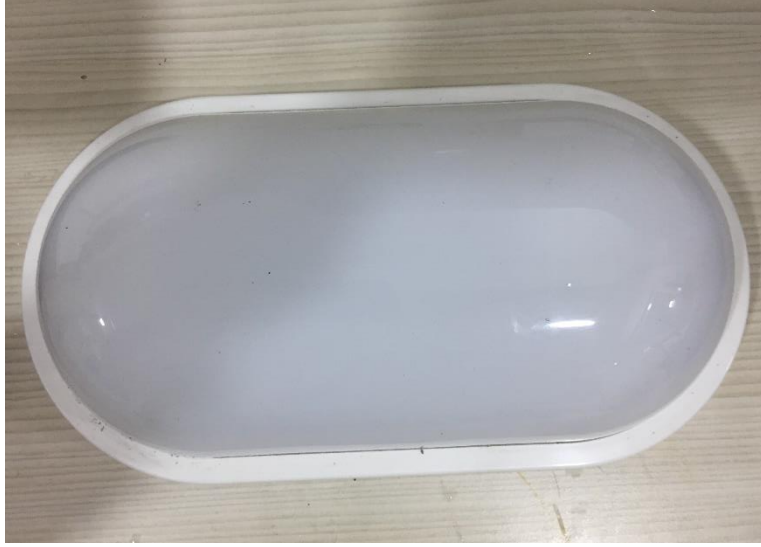
Photo 1. General view of the model LEDLIGHT-4

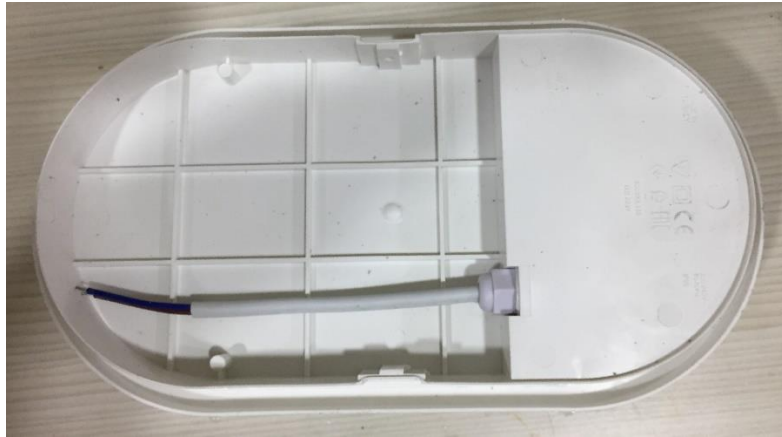
Photo 2. General view of the product

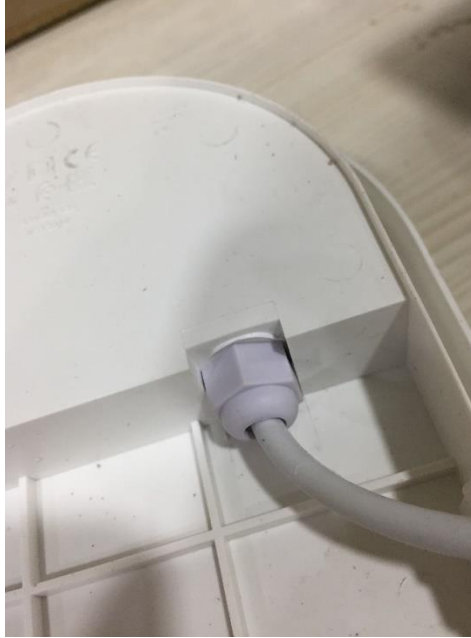
Photo 3. Supply cord of the product

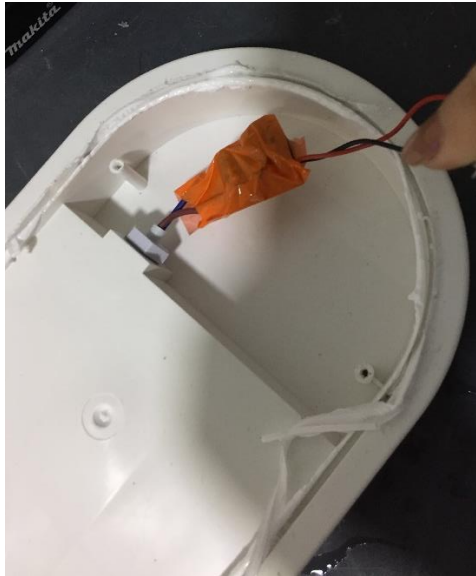
Photo 4. Inside of the product

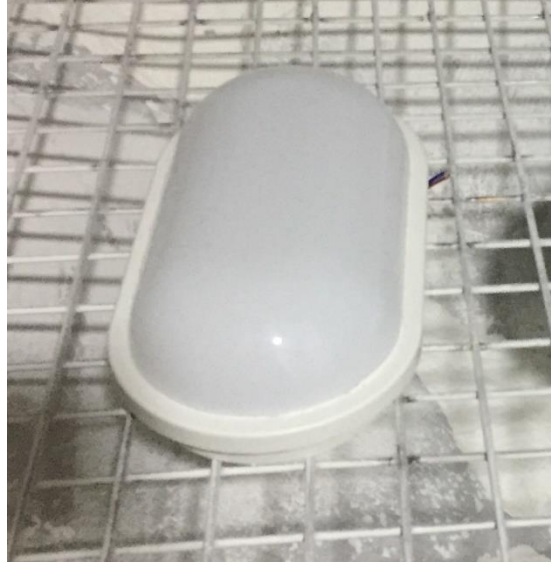
Photo 5. Test condition for IP6X

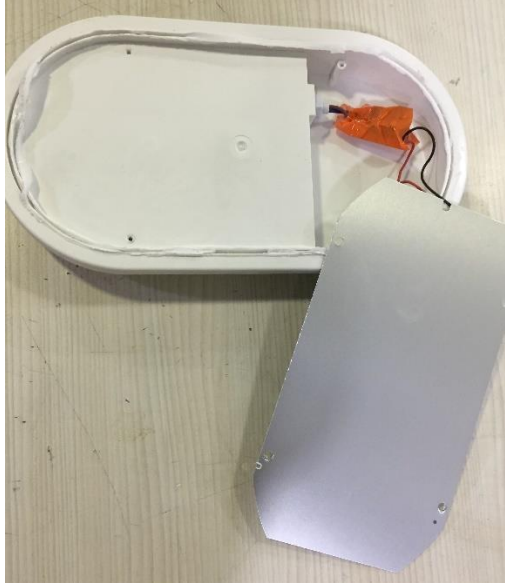
Photo 7. Inside of view after the IP 6X test

Madde /Clause	Tanım /Description	Ortam Şartları /Ambient Conditions	Sonuç /Result
S21.1385 (Model LEDLIGHT-2)			
9.2.2.	After the IP6X test, there was no dust ingress	24°C / %50Rh	P
S21.1386 (Model LEDLIGHT-4)			
9.2.2.	After the IP6X test, there was no dust ingress	24°C / %50Rh	P
S21.1384 (Model LEDLIGHT-2)			
9.2.6.	After IPX5 test no water residue appears inside	24°C / %50Rh	P
10.2.2.	During the test occurred no flashover or breakdown (1480 V)	24°C / %50Rh	P
S21.1388 (Model LEDLIGHT-4)			
9.2.6.	After IPX5 test no water residue appears inside	24°C / %50Rh	P
10.2.2.	During the test occurred no flashover or breakdown (1480 V)	24°C / %50Rh	P
P: Uygun / Conformed F: Uygunsuzluk / Non-Conformity N/A: Uygulanabilir değil / Not Applicable

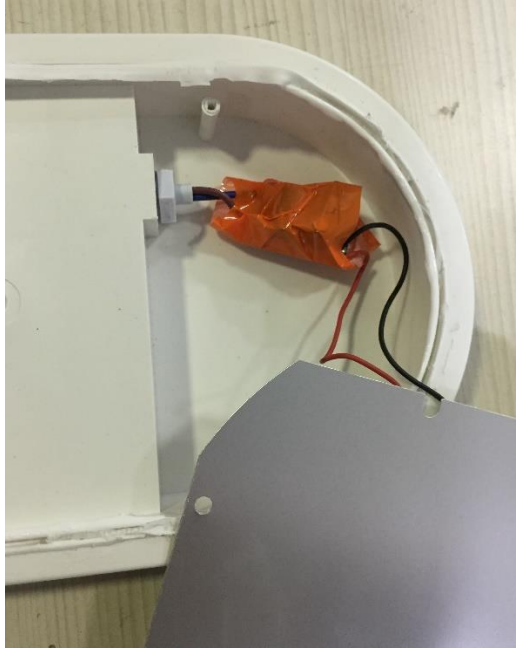
Photo 8. Internal wiring of the product

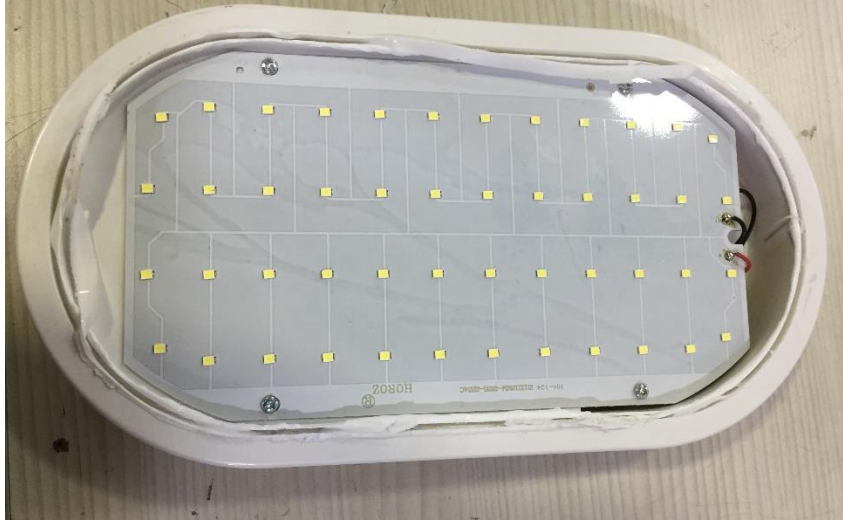
Photo 8. Inside of view after the IP 6X test

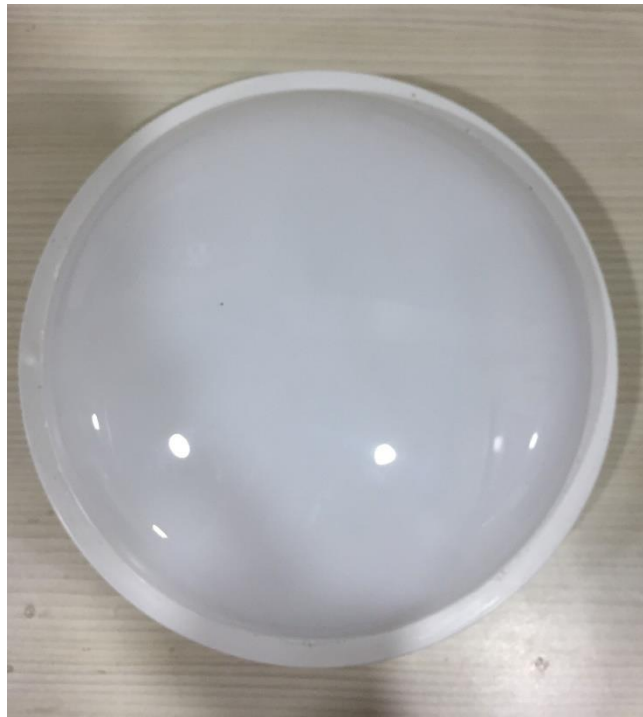
Photo 9. General view of the model LEDLIGHT-2

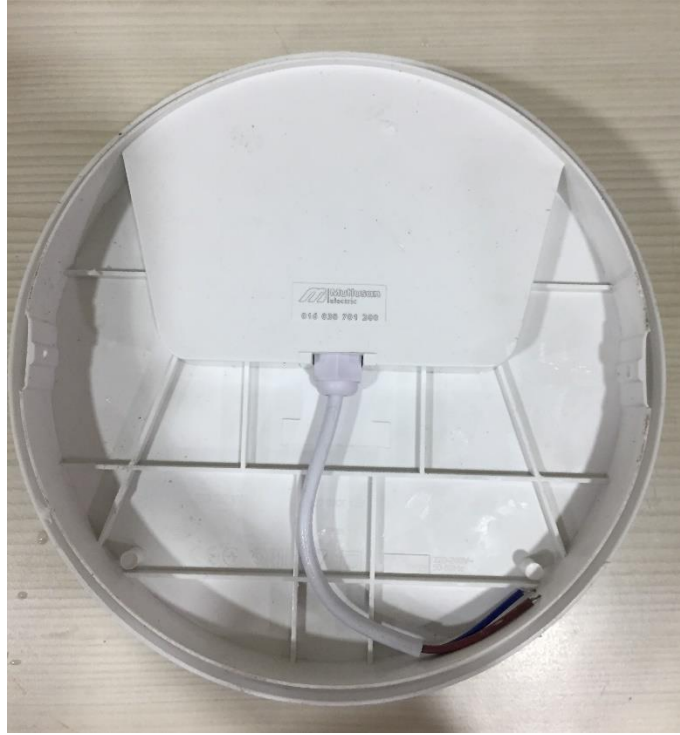
Photo 9. General view of the product

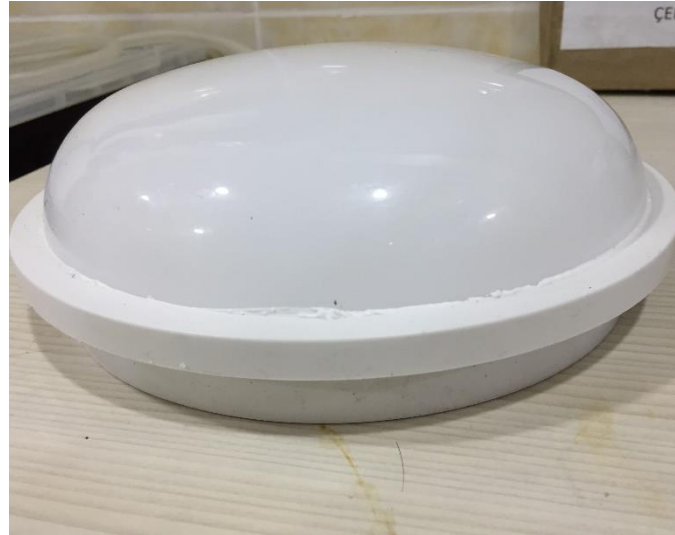
Photo 10. Side view of the product

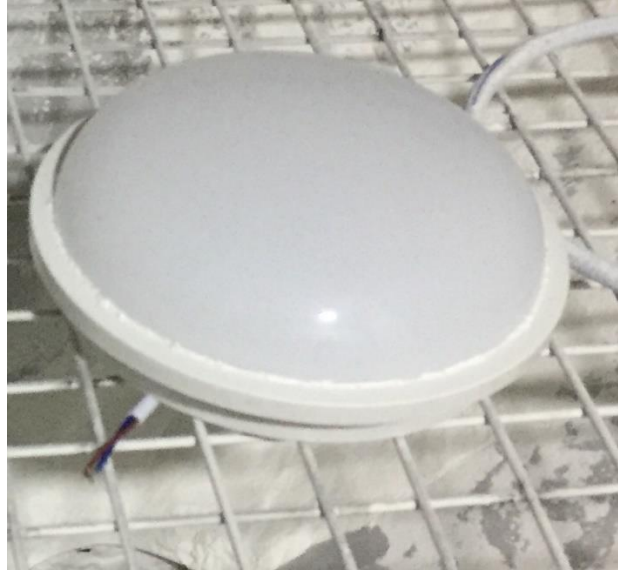
Photo 11. Test condition for IP6X

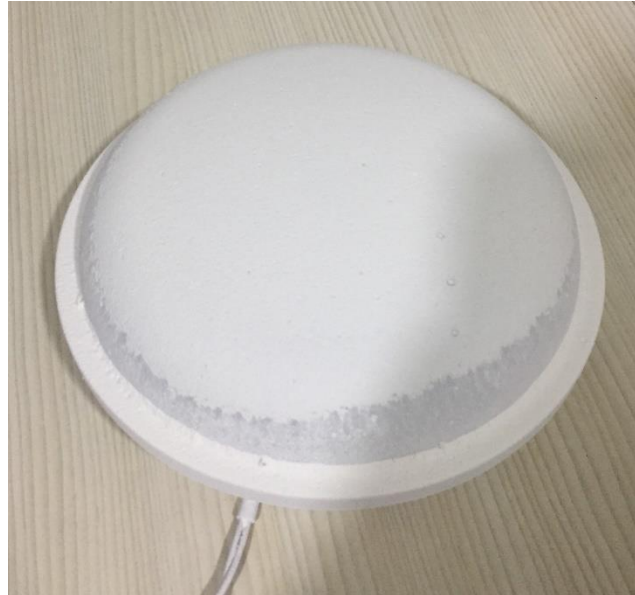
Photo 11. General view of after the IP 6X test

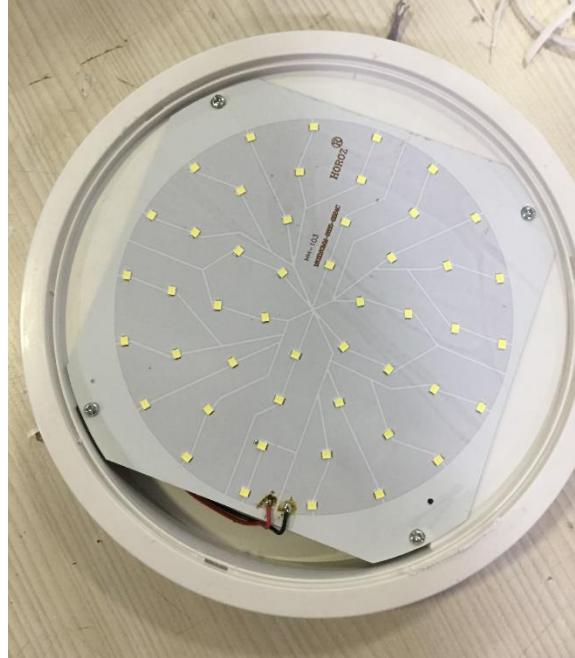
Photo 11. Inside of view after the IP 6X test

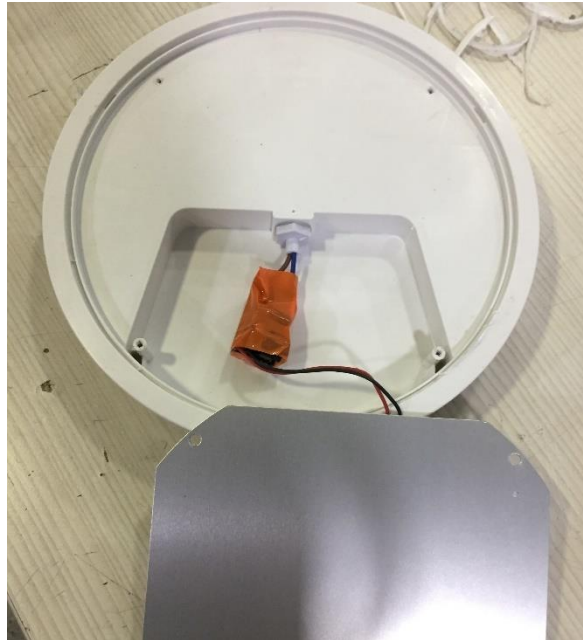
Photo 12. Inside of view after the IP 6X test

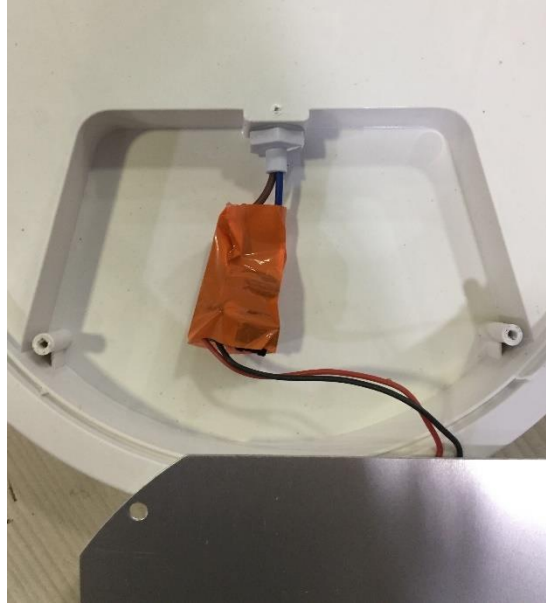
Photo 13. Internal wiring of the product

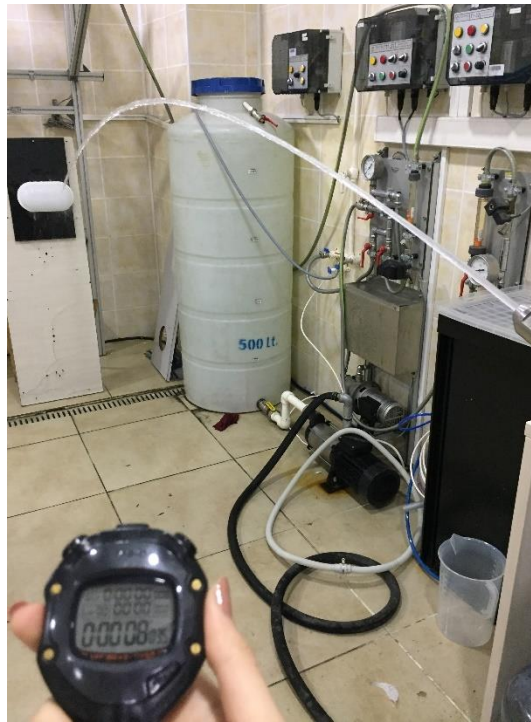
Photo 14. Test condition of model LEDLIGHT-4 for IP X5 test

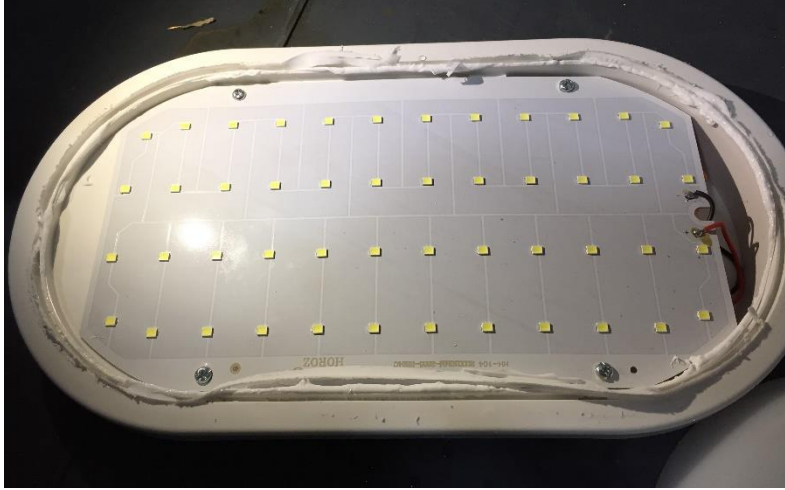
Photo 15. Inside of view after the IP X5 test

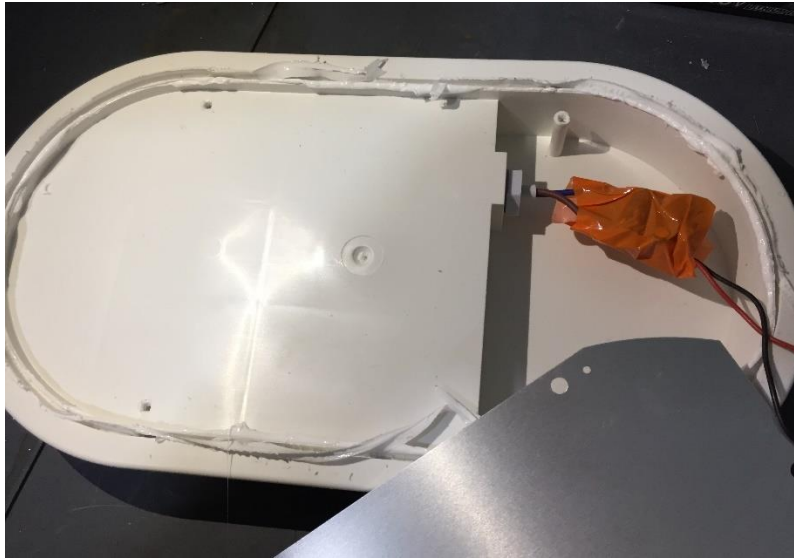
Photo 16. Inside of view after the IP X5 test

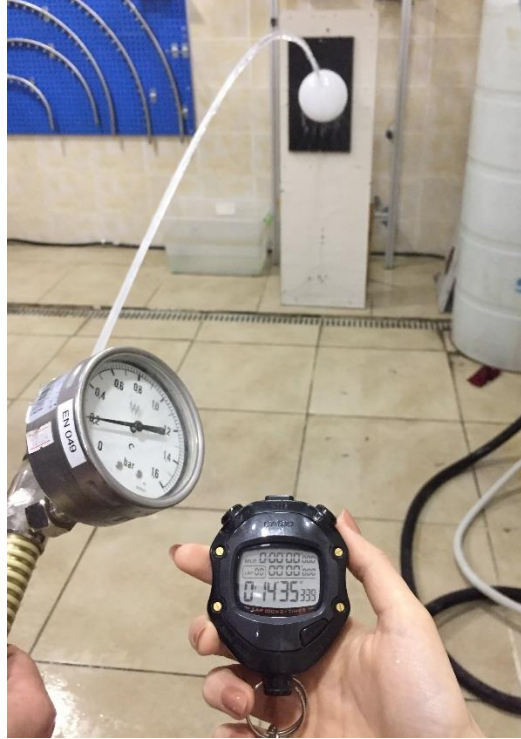
Photo 17. Test condition of model LEDLIGHT-2 for IP X5 test

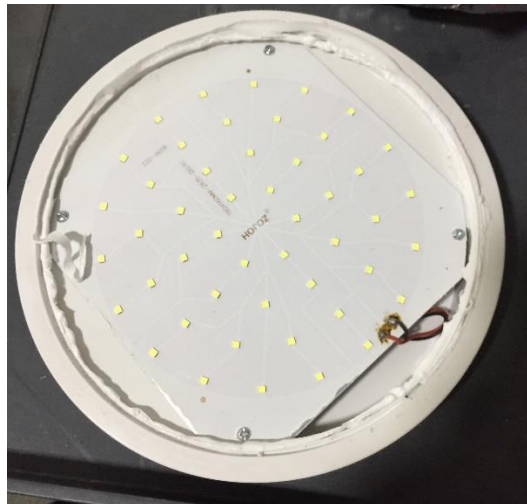
Photo 18. Inside of view after the IP X5 test

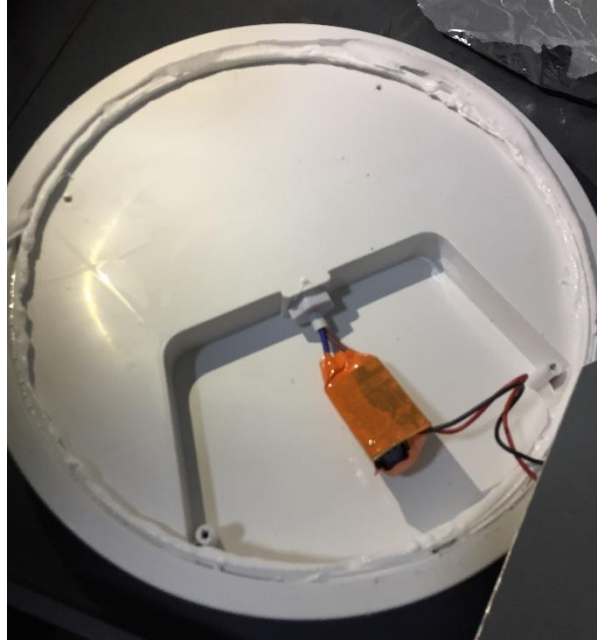
Photo 19. Inside of view after the IP X5 test

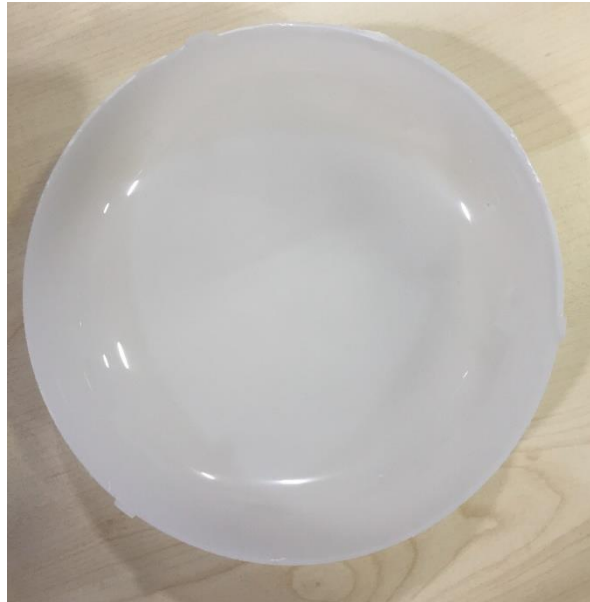
Photo 20. Inside of view after the IP X5 test
